Manhole Inspection Summary

Manhole # S15EE1005MH

Insp Date: **3/6/07 10:13 AM**

Location Address: **3839 ROLAND VIEW AVE**

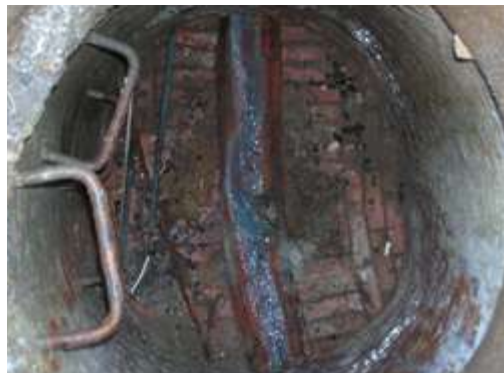
Top View

☒ **Debris** (not Condition related)

☒ **Corroded**

☒ **Evidence Of Surcharge**

Evidence of surcharge - Bench debris.
Corroded steps.

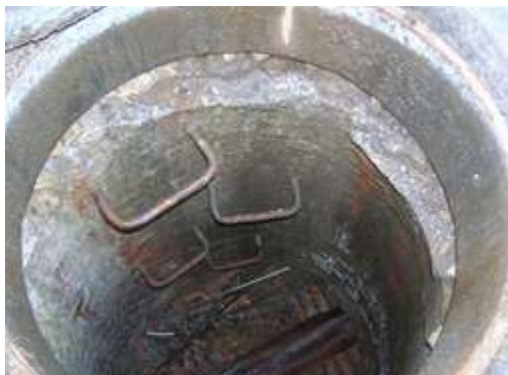
Defect

Offset: **3** (in.)

☒ **Leaks**

Condition: ☐ Sound ☐ Cracked ☐ Root Intrusion ☐ Loose Brick ☒ **Deteriorated**

Infiltration: ☐ None ☒ **Joint** ☐ Cracks ☒ **Mortar** ☐ Roots ☐ Wall

Frame leaks. Frame offset. Adjustment
deterioration and infiltration.

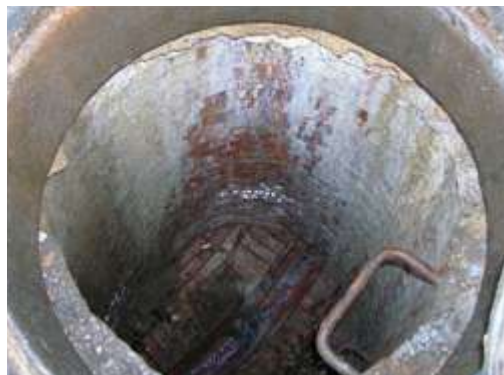
Defect

Frame leaks. Frame offset. Adjustment
deterioration and infiltration - other side.

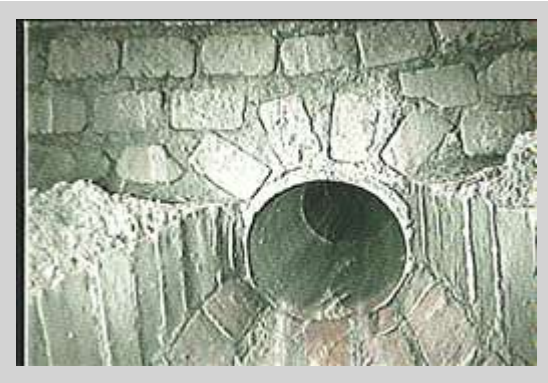
Pipe Out @ 12 O'Clock

Condition: ☐ Sound ☐ Cracked ☐ Root Intrusion ☐ Loose Brick ☒ **Deteriorated**

Infiltration: ☐ None ☐ Joint ☐ Cracks ☒ **Mortar** ☐ Roots ☐ Wall

Barrel deterioration and infiltration.

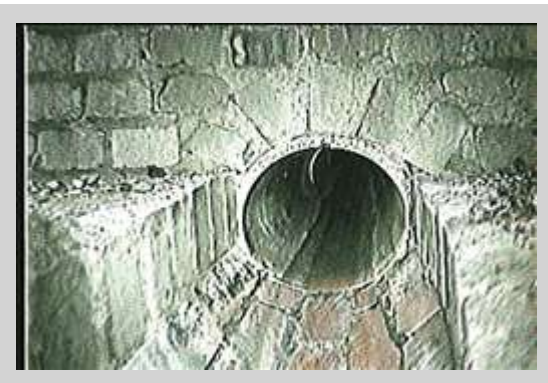
Pipe In @ 5 O'Clock

Condition: ☐ Sound ☐ Cracked ☐ Root Intrusion ☒ **Deteriorated** ☐ Leaks ☐ Debris

Channel deterioration.
